# **GREEN SHEET**

### **Informational Summary Report of Serious CAL FIRE Injuries, Illnesses, Accidents and Near-Miss Incidents**

#### **Inmate Serious Injury / Tree Felling Incident**

**Highway 89  
09-CA-LMU-005999**

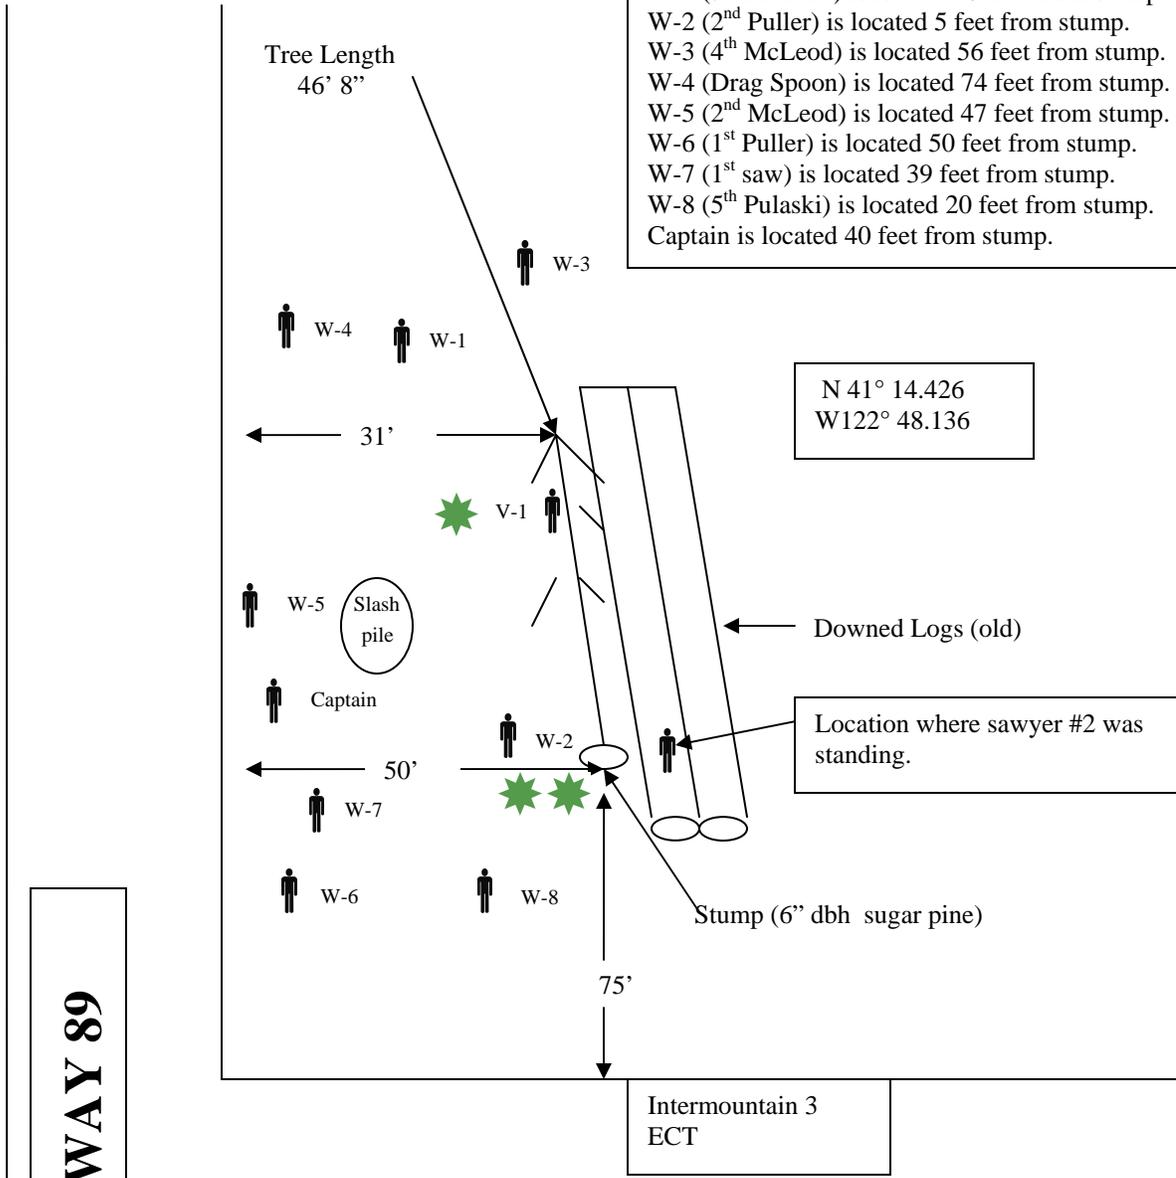
# Highway 89 Incident

V-1 (3<sup>rd</sup> McLeod) is located 35 feet from stump.  
 W-1 (5<sup>th</sup> McLeod) is located 49 feet from stump.  
 W-2 (2<sup>nd</sup> Puller) is located 5 feet from stump.  
 W-3 (4<sup>th</sup> McLeod) is located 56 feet from stump.  
 W-4 (Drag Spoon) is located 74 feet from stump.  
 W-5 (2<sup>nd</sup> McLeod) is located 47 feet from stump.  
 W-6 (1<sup>st</sup> Puller) is located 50 feet from stump.  
 W-7 (1<sup>st</sup> saw) is located 39 feet from stump.  
 W-8 (5<sup>th</sup> Pulaski) is located 20 feet from stump.  
 Captain is located 40 feet from stump.
