# NATIONAL INTERAGENCY FIRE CENTER

## NATIONAL FIRE EQUIPMENT SYSTEM CACHE MEMORANDUM NO. 05-2

Subject: Defective 3000 lb. Sling Swivels, NFES #0526, NSN #1670-01-029-8555

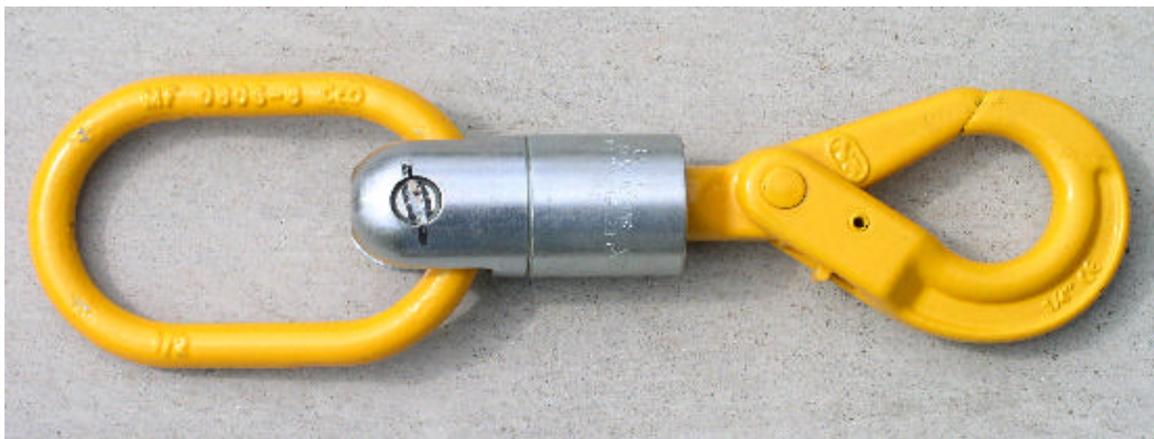
Figure 1, Esmet, Inc. 3000 lb. Swivel

Background: During restocking of helicopter kits at the Ontario Fire Cache, several new 3000 lb. swivels were found to be frozen, meaning the hook would not turn. An investigation was started and the manufacturer was contacted. The problem is a latent defect caused by the assembly process. A method of inspection has been developed to identify the problem sling swivels and is described below.

Identifying the Product: Figure 1 shows the only known style of suspect swivels. The only manufacturer is Esmet, Inc. The date of manufacture for all discovered so far carry a date code of "9 03". The date stamp is located just below the manufacturer's name and the load rating on the silver colored swivel assembly. The manufacturer has stated that this style of sling swivel (figure 1) may have production dates as early as October, 2002 (marked "10 02").

Reporting/Replacement Process: Defective sling swivels should be returned to GSA for replacement without charge. GSA will also assume all associated shipping costs. Owners of defective Esmet, Inc. manufactured sling swivels should contact Robert Regan, GSA National Customer Service Center, at 1-800-525-8027 (select "option 2") for specific disposition/shipping instructions. Returns on defective sling swivels will be accepted for free replacement only until September 1, 2005.

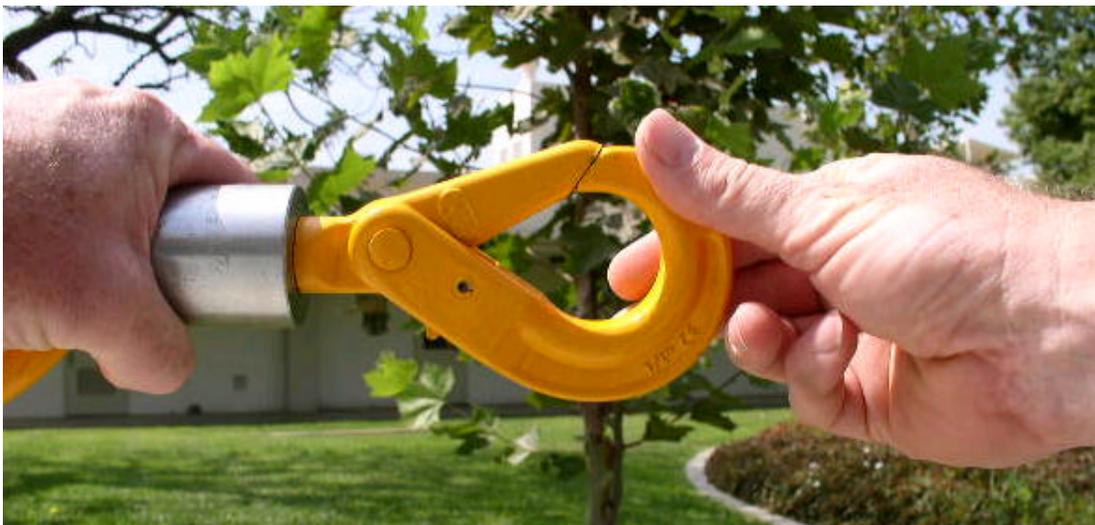
**Figure 2, Finger Turning Test**

3000 Lb. Cargo Swivel Inspection: Grasp the swivel body in one hand. Using the thumb and forefingers of the other hand attempt to turn the hook (see figure 2). If the hook does not turn at all under finger pressure, the swivel has the problem and must be set aside for return to the vendor. If the hook turns under finger pressure but has locations of “binding” during the revolution, the swivel is acceptable for returning to stock/supply.

Once you have determined the bearing is frozen do not attempt to break it free. Several swivels were found frozen and the inspector continued to work at twisting the hook which resulted in freeing of the bearing. This results in the inability to confirm the problem by the manufacturer when they receive it.

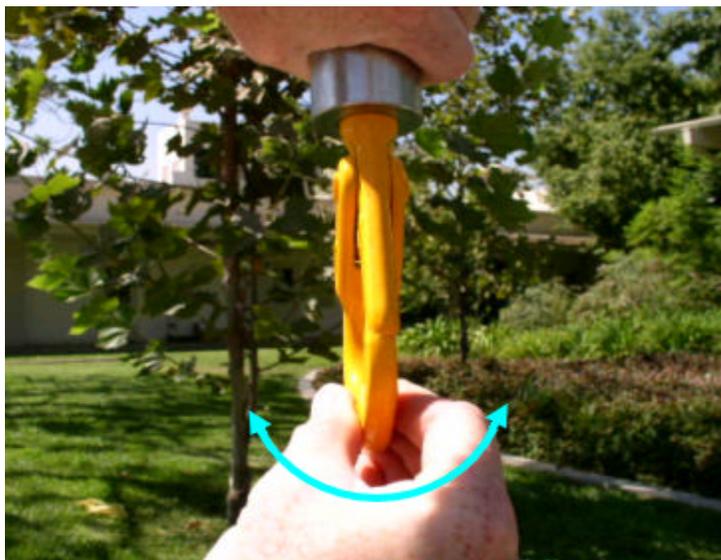
**Figure 3, Lateral Movement**

If lateral movement of the hook is found during inspection of the 3,000 lb. swivels, this does not affect serviceability and they may be returned to stock. Lateral movement is a side to side “swinging” movement of the hook under finger pressure, as shown in figure 3.
