August 13, 2013

NATIONAL FIRE EQUIPMENT SYSTEM CACHE MEMORANDUM NO. 13-2

Subject: Recall, Hoseline Tee with Valve, NFES #0230

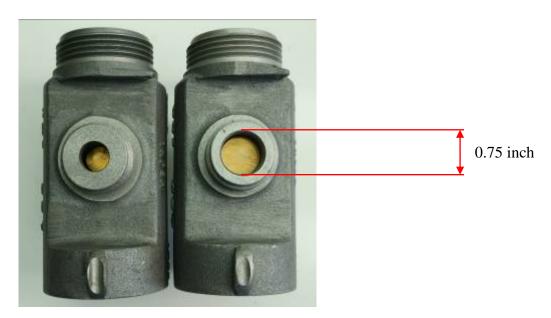
2. Branch Waterway Orifice – large diameter 0.75 inch waterway (Figure 3)

Figure 3--large 0.75 inch diameter on branch waterway for potentially affected tees (right) versus an unaffected tees ^a (left)

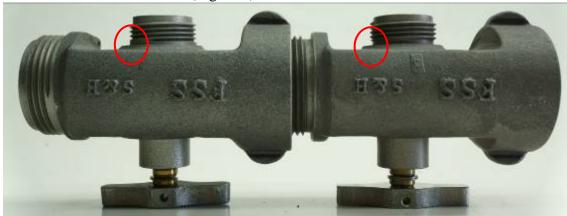
3. Lack of Thread Relief (Figure 4)

Figure 4--comparison between potentially affected tee (without thread relief; left) and unaffected tee (with thread relief; right)

NISC: Each cache should identify the potentially affected units in inventory through the above visual cues. You can then test the units to see if they have the manufacturing error.

To determine if a hoseline tee should be replaced, simply rotate the valve handle clockwise to a full stop position. You should feel a hard stop. If the valve handle continues to rotate even after the valve is fully seated in a closed position, it must be replaced. The earlier video describes this procedure in detail: http://youtu.be/NT81zJ2YzUg.

S&H Products has agreed to repair or replace any affected hoseline tees. Send defective units directly back to the manufacturer for exchange/repair at the following address:
