NATIONAL INTERAGENCY FIRE CENTER

NATIONAL FIRE EQUIPMENT SYSTEM CACHE MEMORANDUM NO. 20-02

Subject: 6000 Lb. Cargo Net (NFES 0458)

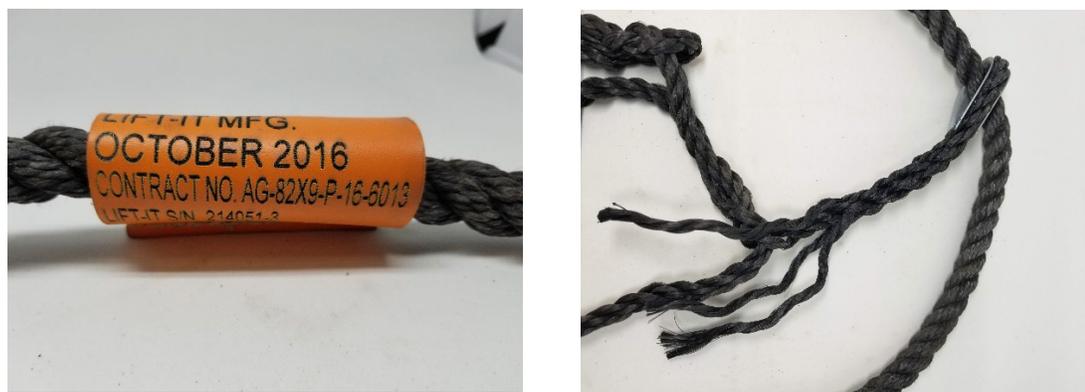
During routine inspection, several 6000 lb. cargo nets (NFES 0458) were determined to not meet serviceable standards due to fraying rope ends and the number of minimum tucks in rope terminations and splices. The subject nets were purchased through a National Interagency Support Cache (NISC) procurement and are likely to be in multiple NISC inventories. This memorandum pertains to the NFES 000458 cargo nets manufactured by Lift-It Manufacturing, Inc. in 2016, under contract number AG-82X9-P-16-6013 (Figure 1).

Figure 1—Example of the inspected NFES 000458 cargo net

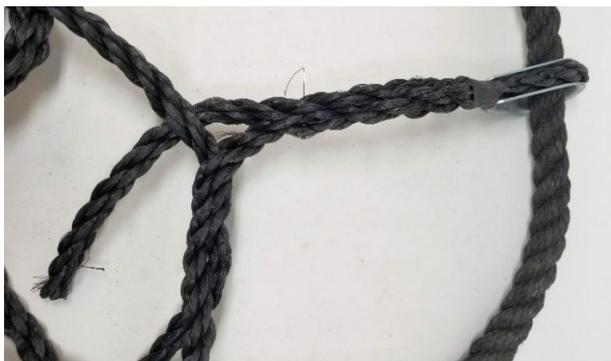
Figure 2—Example of a rope end that has been braided past the splice and tucked underneath a different strand. Note that the splice has four (4) tucks.

1. Visually inspect all rope terminations and splices for the minimum number of tucks. Note that due to the length of some of the rope ends past the splice, some rope ends were tucked between other rope strands to constrain the extra rope (Figure 2). This condition is acceptable if the splice or termination itself contains the required minimum number of tucks. If any termination or splice has fewer than four tucks, the net should be removed from service.

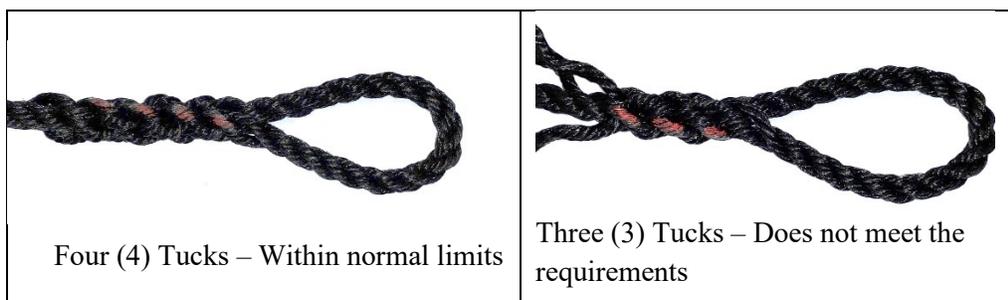
Upon additional inspection by the National Technology and Development Program (NTDP) and in coordination with the manufacturer, it is likely that most nets are still considered serviceable. The 0458 nets are required to incorporate a minimum of four tucks in all rope terminations and splices; NTDP determined that all terminations and splices in the two nets inspected had the required minimum number of tucks. Furthermore, NTDP determined that some of the rope ends of the net had become unlayed and exhibited substantial fraying of the fibers at the end; terminations for rope ends for the 000458 nets are required to be “heat cut” to eliminate fraying.

Figure 3—Comparison of a compliant splice that has four tucks with a non-compliant splice that has three (3) tucks.

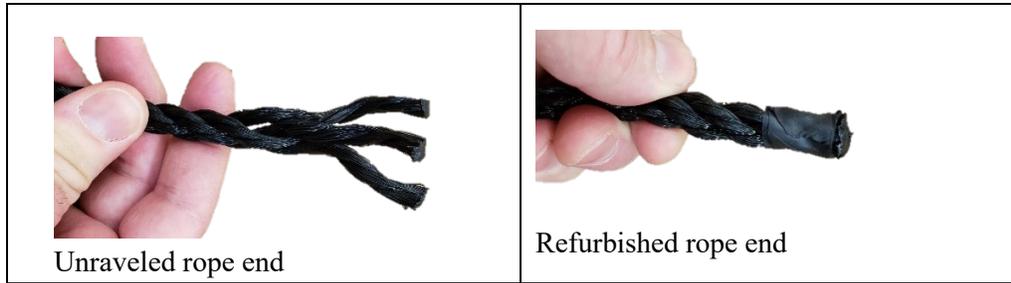
Figure 4—Comparison of a non-refurbished rope end with a refurbished rope end.

2. Inspect all rope ends for fraying or unraveling. Rope ends should be refurbished in accordance with the Polypropylene Rope Terminus Taping Instructions (attached, and posted: <https://www.nwgc.gov/sites/default/files/publications/448-000458-taping-instructions.pdf>).
