Part One

A. Dude Fire Summary

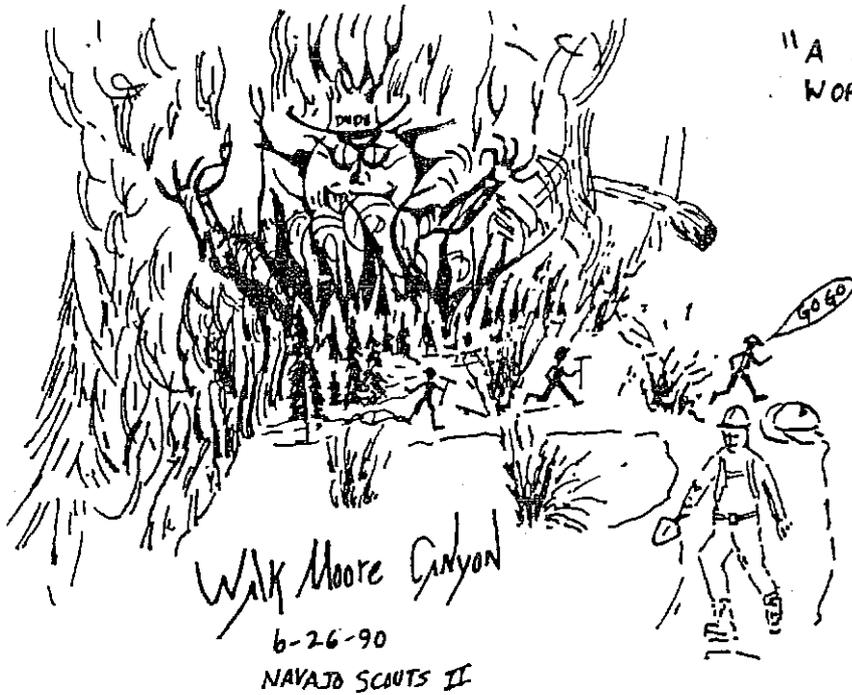
"A GOOD SCARE IS ALWAYS
WORTH MORE THAN A GOOD ADVICE"

Shortly after Louis Sorrell, Navajo Scouts 2 Crew Boss, had escaped the Dude Fire blow-up, he took a few moments to gather his thoughts and began drawing his impression of the experience on the back of his crew time report book. Other crew members asked if they could contribute to his work. The above illustration (a duplicated rendition) is the result of their efforts – their impression of the Dude Fire, with the accompanying quote: "A good scare is always worth more than good advice."
