Lessons Learned from Waldo Canyon

FIRE ADAPTED COMMUNITIES
MITIGATION ASSESSMENT TEAM FINDINGS

Insurance Institute for Business & Home Safety®

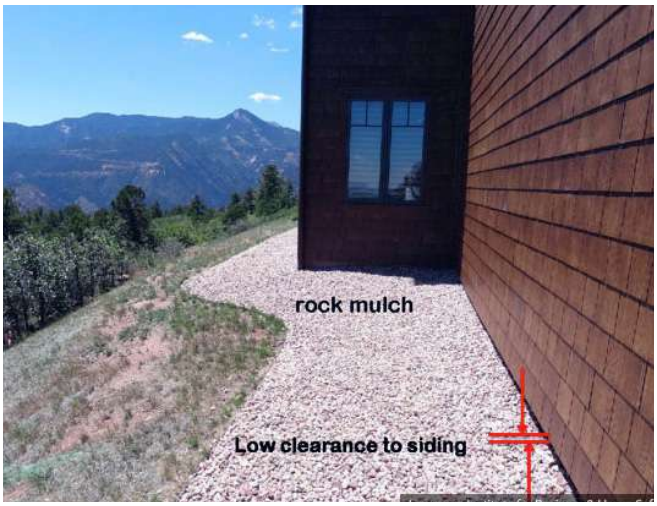
Figure 22: The back side of the home on Outer Vista Point Road. Noncombustible rock mulch and fiber-cement shingle siding products were used. The low clearance may allow for the underlying wood-based sheathing product to be vulnerable to ember accumulation at the base of the wall. Source: IBHS.

For the condition at the front of the Outback Vista Point Road home, where combustible mulch was used near the home, the best option would be to use noncombustible siding and noncombustible mulch products to reduce the vulnerability of the home to a wind-blown ember exposure.

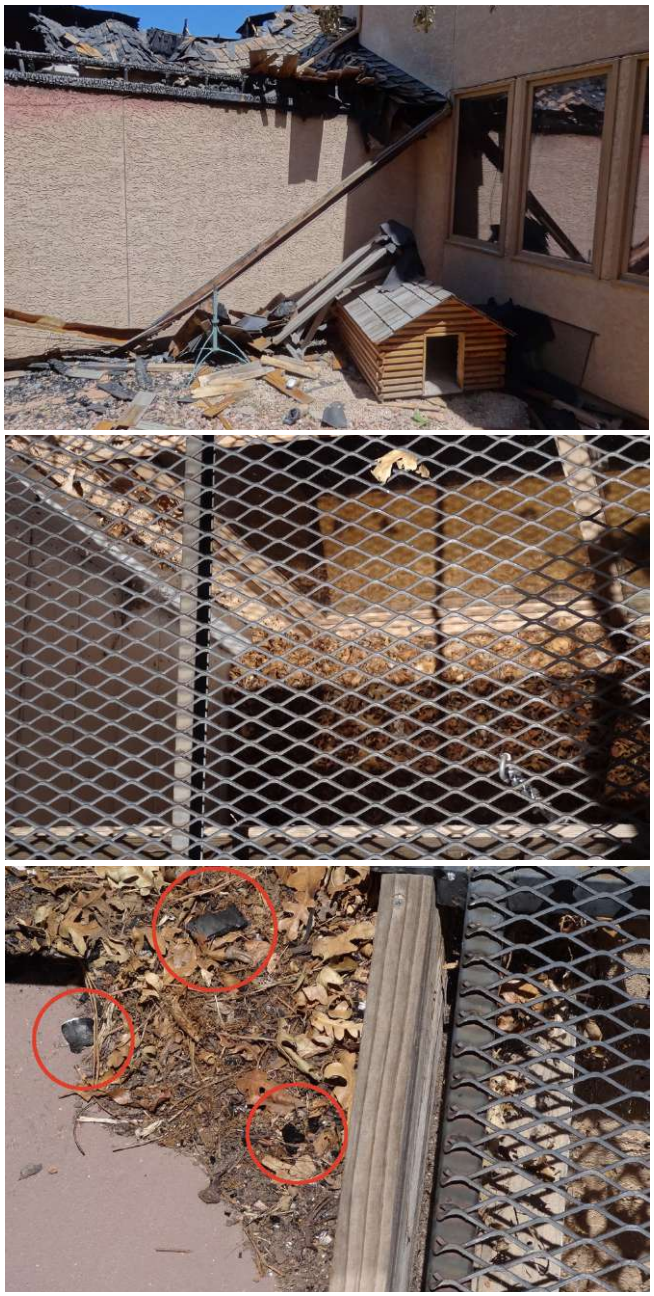
Figure 26: Combustible materials were present in the near-home zone of the Rossmere Street home. Embers are evident in the right-hand middle photo (embers circled in red). Source: IBHS.

Each of the two homes with wood shake roof coverings also had relatively poor defensible space in the near-home, 0-5 foot zone (Figures 26 and 27), and an ember exposure to near-home combustible materials was evident. The front of the Rossmere Street home had a design feature that,

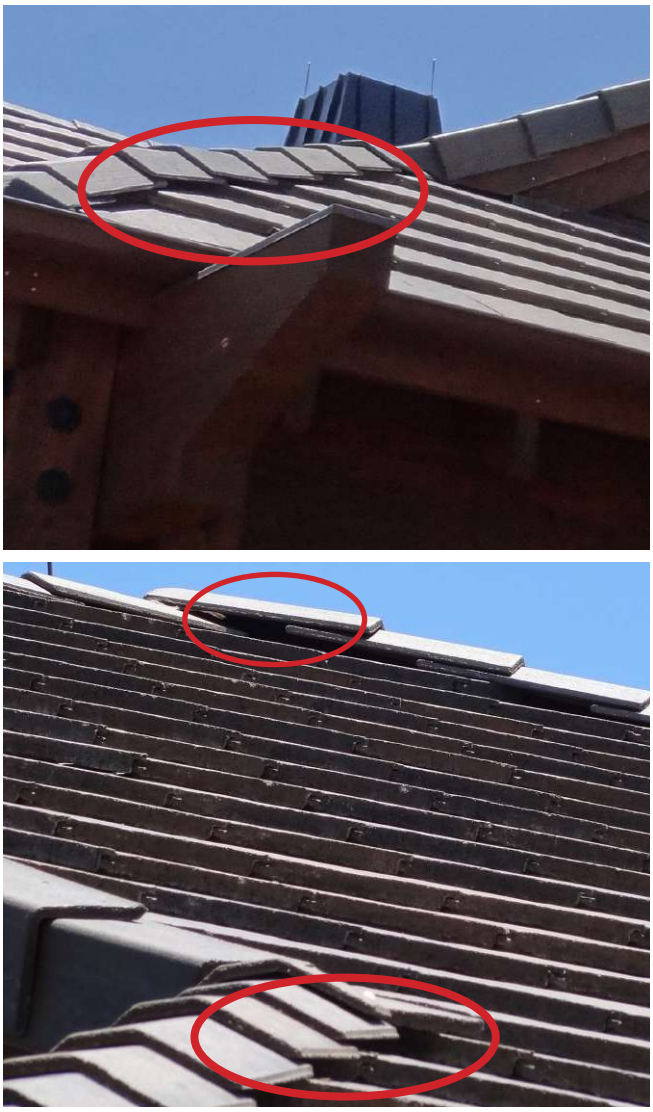
Figure D8: Un-stopped/unblocked openings at the hips of the flat-tile roof. Source: IBHS.

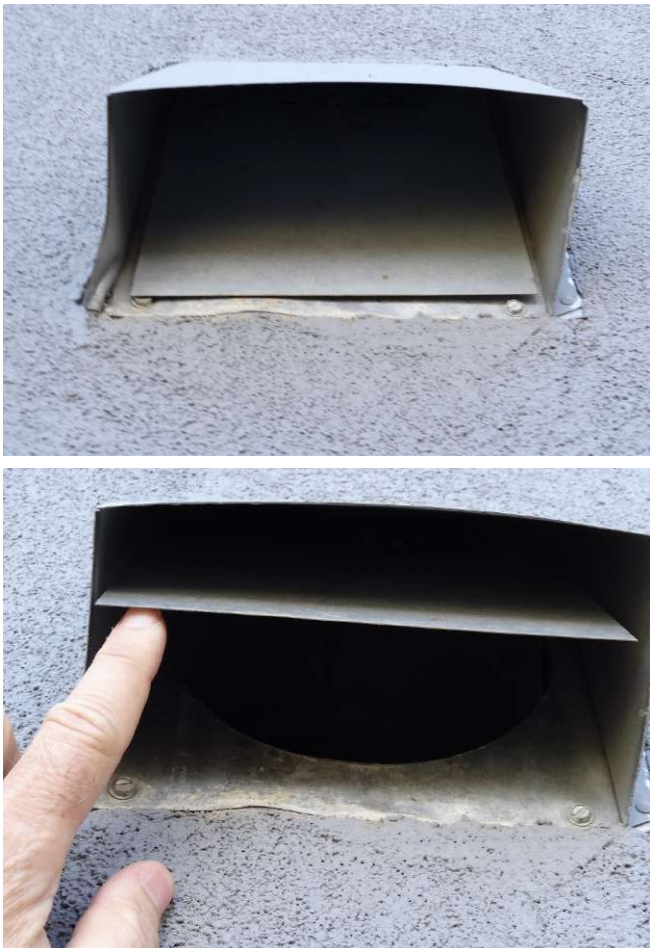
Figure D24: Dryer and other exhaust vents used vents coverings that were normally closed (upper left); when operating positive pressure in the duct would force open the closure flam to at the outlet. Source: IBHS.

Figure D25: A flat concrete tile was used for the roof covering on this house. Note the openings at the hip and edge of the roof. Source: IBHS.

This house had a flat-tile covering (Figure D25). As was the case with the Outer Vista Point Road home the hip openings were not plugged with a noncombustible materials (e.g., with a mortar mix). As a result of the installation details of this covering, openings also occurred at the end of the roof (i.e., the area above the gutter) along the ridge and hip that must also be plugged with a noncombustible material. These openings should be plugged to minimize the opportunity for embers to get under the noncombustible roof covering, potentially igniting fine fuels that have accumulated.
